**Flood Control Project Maintenance
Levee Inspections**
LMA District Cover Sheet
Spring 2017 Levee Inspection Results

Reclamation District No. 0536 Egbert

Spring 2017 Levee Inspection Results

Waterway			Bank	Unit Miles
Unit No. 01 Lindsey Slough			Right	5.58
	Spring (March - May)	Summer (June - August)	(September - November) Fall	Winter (December - February)
Unit Maintenance Rating (Fall Only)				
Date of Inspection	4/11/2017 - 4/11/2017			
DWR Inspector	Herman Phillips			
Accompanied By

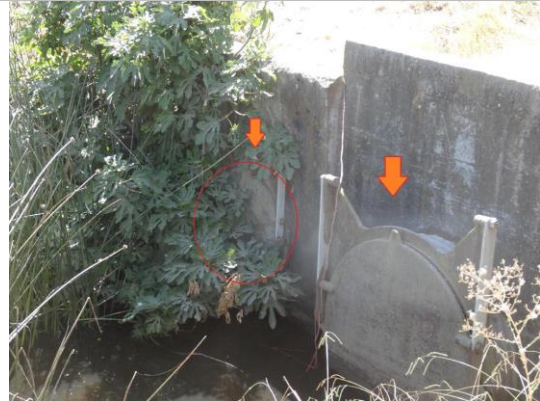
Photo 1 of 3 : UCIP_SP_2017_50161_34457.jpg

Comment Code					
Inspector Comment					
FS_ID:50161 DS_ID:22712 EP_NO: 10114 Repair Type: Urgent Crossing Status: Found UCIP Comments: 06/01/2016: Holes and heavy corrosion inside pipe on WS have gotten worse. Flapgates appear in good condition though vegetation blocks view of flapgate for 36-inch on WS. These pipes are still in use and necessary for drainage; pipes may be eligible for repair under DWR Deferred Maintenance Program. (K. Fazel - UCIP)08/13/2013:- Holes in pipe outlet due to heavy corrosion.- Needs detailed investigation of the pipe.- Headwall cracked and tilted on WS. (P. Amatya - DWR) FIELD_STRUCT_DESC: 1 of 2: 60-inch corrugated metal drainage pipe through the levee, 10 feet below the crown. Flap gate on the waterside (WS) and headwall on the WS and landside (LS). Culverts run under the road to provide drainage from agricultural fields to Lindsey Slough. RD0536 president is David Hearn at hearnd5@gmail.com. (Automatic Board Order (ABO) issued as Permit No. 10114, 1974 - Patterson) [Additional Reference(s): DWR Levee Log, 1992. USACE Sacramento O&M Manual 106, May 1953 (Station 294+49)]. FS Date: 6/1/2016

WS view: two CMPs with flap gates. Concrete headwall supports the pipes. A 36" CMP (left) and 60" CMP (right).

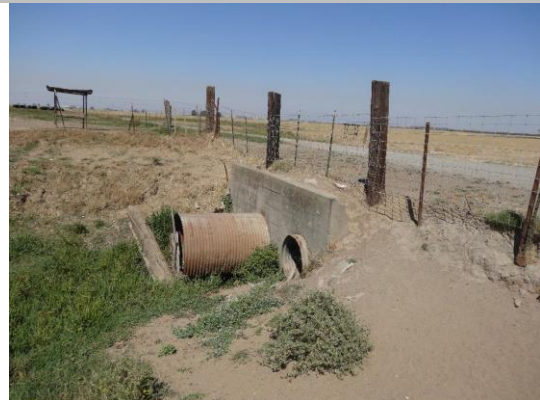
Photo 2 of 3 : UCIP_SP_2017_50161_34456.jpg

LS view: two inlet CMPs with flap gates. Concrete headwall supports the pipes. A 36" CMP (right) and 60" CMP (left).

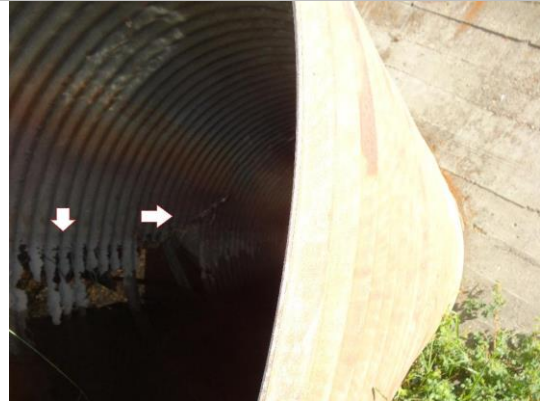
Photo 3 of 3 : UCIP_SP_2017_50161_34455.jpg

Comment Code					
Inspector Comment					
FS_ID:50161 DS_ID:22712 EP_NO: 10114 Repair Type: Urgent Crossing Status: Found UCIP Comments: 06/01/2016: Holes and heavy corrosion inside pipe on WS have gotten worse. Flapgates appear in good condition though vegetation blocks view of flapgate for 36-inch on WS. These pipes are still in use and necessary for drainage; pipes may be eligible for repair under DWR Deferred Maintenance Program. (K. Fazel - UCIP)08/13/2013:- Holes in pipe outlet due to heavy corrosion.- Needs detailed investigation of the pipe.- Headwall cracked and tilted on WS. (P. Amatya - DWR) FIELD_STRUCT_DESC: 1 of 2: 60-inch corrugated metal drainage pipe through the levee, 10 feet below the crown. Flap gate on the waterside (WS) and headwall on the WS and landside (LS). Culverts run under the road to provide drainage from agricultural fields to Lindsey Slough. RD0536 president is David Hearn at hearnd5@gmail.com. (Automatic Board Order (ABO) issued as Permit No. 10114, 1974 - Patterson) [Additional Reference(s): DWR Levee Log, 1992. USACE Sacramento O&M Manual 106, May 1953 (Station 294+49)]. FS Date: 6/1/2016

LS view: holes & cracks on CM pipe due to heavy corrosion. Needs detailed investigation of the pipe.

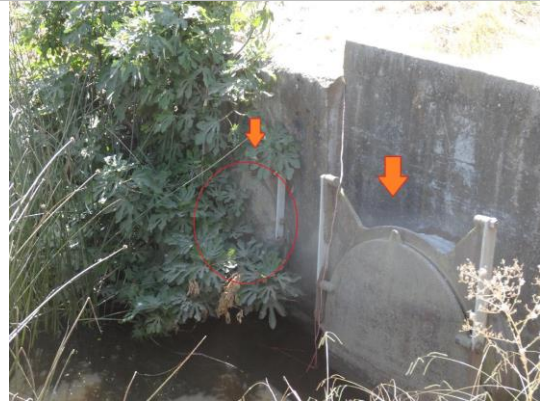
Photo 1 of 3 : UCIP_SP_2017_50160_34771.jpg

Comment Code					
Inspector Comment					
FS_ID:50160 DS_ID:22726 EP_NO: 10114 Repair Type: Urgent Crossing Status: Found UCIP Comments: 06/01/2016 Pipe is not abandoned. Though neglected, it is still functional and a needed system feature. Pipe is severely corroded with holes in it, which are visible on LS. Vegetation blocks view of flapgate on WS. Pipes may be eligible for repair under DWR Deferred Maintenance Program. (K. Fazel - UCIP)08/13/2013 This pipe seems to be abandoned. Headwall cracked and tilted on WS. (P. Amatya) FIELD_STRUCT_DESC: 2 of 2: 36-inch corrugated metal drainage pipe through levee, 10 feet below the crown. Flap gate on the waterside (WS) and headwall on the WS and landside (LS). Culverts run under the road to provide drainage from agricultural fields (via LS ditch) to Lindsey Slough. RD0536 president is David Hearn at hearnd5@gmail.com. (Automatic Board Order (ABO) issued as Permit No. 10114, 1974 - Patterson). [Additional Reference(s): DWR Levee Log, 1992. USACE Sacramento O&M manual 106, May 1953 (Station 294+49)]. FS Date: 6/1/2016

WS view: concrete headwall, flap gates on 36" CMP (left) and 60" CMP (right)

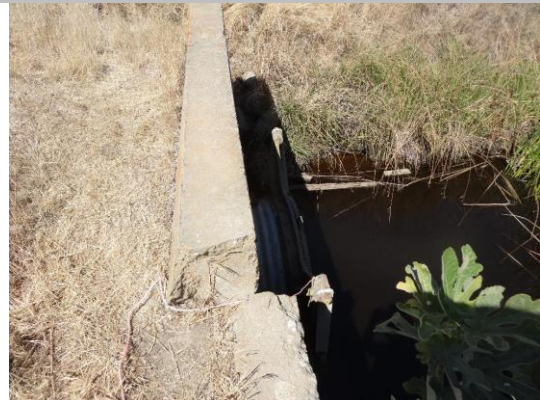
Photo 2 of 3 : UCIP_SP_2017_50160_34770.jpg

WS view: cracked and tilted concrete headwall.

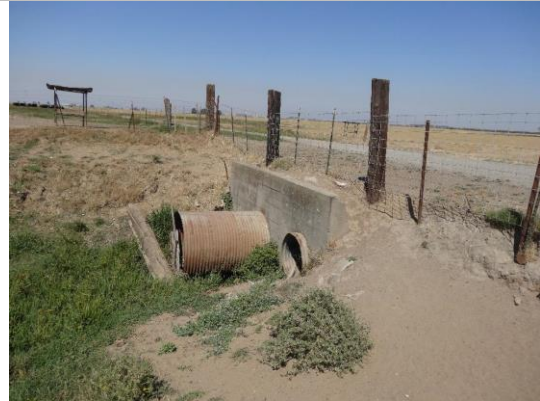
Photo 3 of 3 : UCIP_SP_2017_50160_34769.jpg

LS view: concrete headwall, 36" CMP (right) and 60" CMP (left)

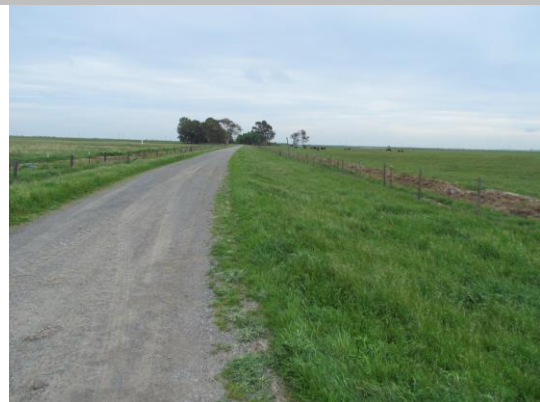
Photo 1 of 1 : SP_2017_RD0536_208_18_20170519_00045.jpg

LM Start	0.02	Rating **	M	Issue No.	18
LM End	2.90	Issue Type +	Ma	Location *	LS
Category	Earthen Levee			GPS Latitude/Longitude	
				Start	End
Item	Vegetation			38.244917 °	38.255787 °
				-121.768533 °	-121.734500 °
DWR ID	DWR_RD0536_01_s_2017_18				
Comment Code					
V1 : Control annual grass and weeds on the levee slopes and easements.					
Inspector Comment					
Control the annual grasses from the levee slope.

RD 536 Unit 1 looking downstream from levee mile 0.02.

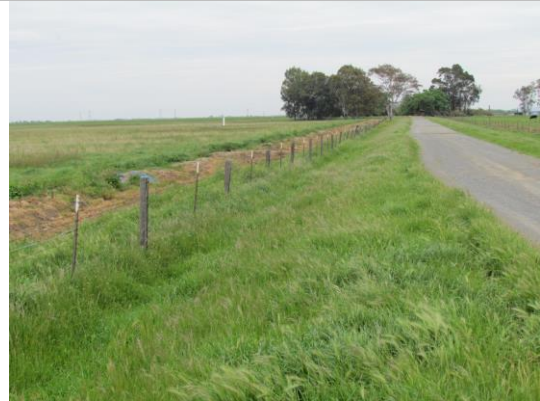
Photo 1 of 1 : SP_2017_RD0536_208_19_20170519_00046.jpg

RD 536 Unit 1 looking downstream from levee mile 0.03.

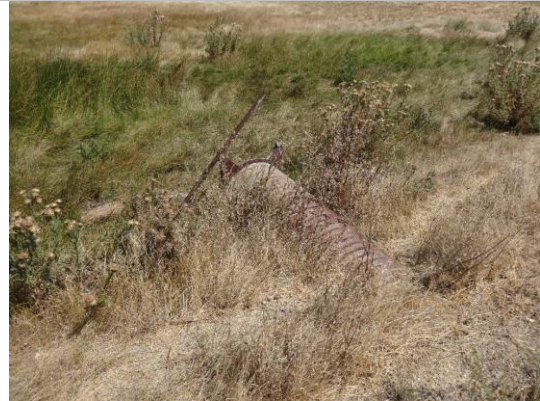
Photo 1 of 3 : UCIP_SP_2017_49313_34774.jpg

FS_ID:49313
DS_ID:22713
EP_NO: 10114
Repair Type: No Action Needed
Crossing Status: Found
UCIP Comments: 06/01/2016 Debris cleared and flapgate is no longer blocked. 08/13/2013 Outlet was blocked by concrete debris and dirt. Needs cleaning of debris.
FIELD_STRUCT_DESC: 24-inch corrugated metal drainage pipe through the levee, 10.5 feet below crown. Flap gate on the waterside (WS). This crossing is also used for irrigation. 1-inch polyvinyl chloride (PVC) pipe sleeved through 24-inch pipe visible through the landside (LS) end. According to David Hearn, district president, the PVC pipe does not connect all the way through. Present (as of 2016) landowner is Solano Land Trust and the pipe runs through the Jepson Prairie Reserve managed by University of California, Davis. [Additional Reference(s): DWR Levee Log, 1992. USACE Sacramento O&M Manual 106, May 1953 (Station 274+00)]. O&M Manual lists two headwalls with this crossing, both of which were not found in 2013 or 2016 (though concrete debris found on WS slope).

WS view: overview of exposed CM pipe on levee slope.

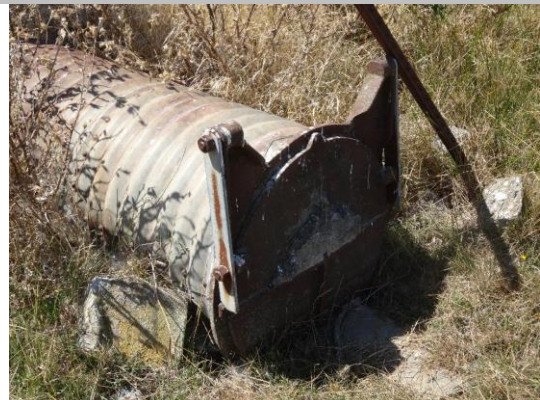
Photo 2 of 3 : UCIP_SP_2017_49313_34773.jpg

WS view: CM pipe blocked by concrete debris on levee slope.

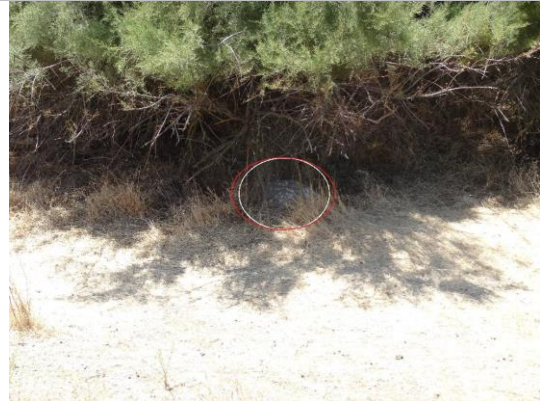
Photo 3 of 3 : UCIP_SP_2017_49313_34772.jpg

LS view: open CM pipe end on levee slope.

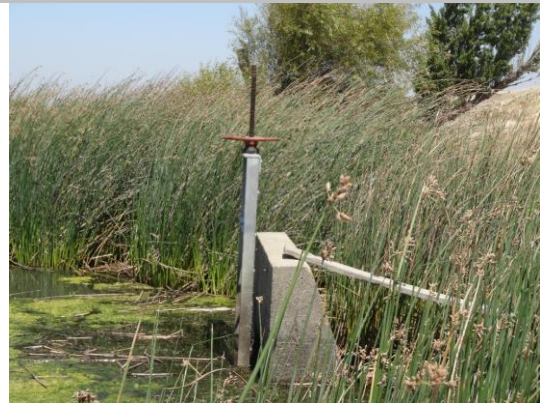
Photo 1 of 2 : UCIP_SP_2017_20444_34493.jpg

LM Start	1.10	Rating **	A/W	Issue No.	69
LM End	1.10	Issue Type +	Ma	Location *	WS
Category	Supplemental			GPS Latitude/Longitude	
				Start	End
Item	DWR UCIP LMA Responsibility			38.255412 °	38.255412 °
				-121.757605 °	-121.757605 °
DWR ID					
Comment Code					
Inspector Comment					
FS_ID:20444					
DS_ID:22715					
EP_NO: 10115					
Repair Type: No Action Needed					
Crossing Status: Found					
UCIP Comments: Pipe was submerged into water and not visible.Steel bar fence on both sides of the levee.					
FIELD_STRUCT_DESC: 42-inch corrugated metal pipe through levee 22.5 feet below crown. Screw gate on waterward end (ABO 10115, 1974). Originally included in the 1953 O&M manual, Sac 106, May 1953.					
FS Date: 8/13/2013

WS view: slide gate, concrete headwall in the channel. Pipe submerged into water.

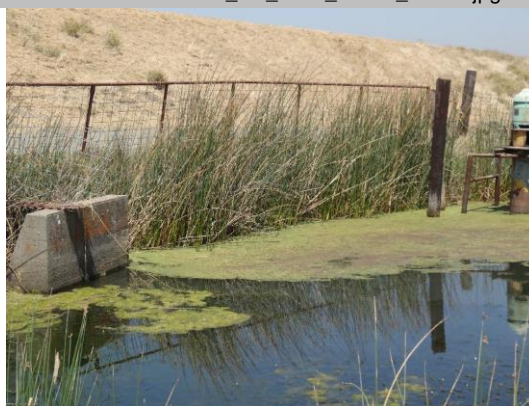
Photo 2 of 2 : UCIP_SP_2017_20444_34492.jpg

LS view: concrete headwall in the channel/irrigation ditch. Pipe submerged into water.

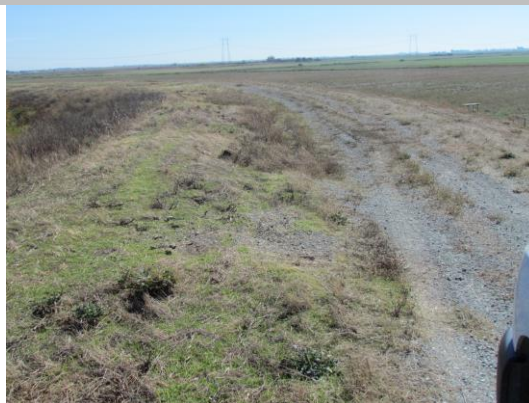
Photo 1 of 4 : SP_2017_RD0536_208_56_20170404_00009.jpg

LM Start	2.69	Rating **	U	Issue No.	56
LM End	2.71	Issue Type +	Ma	Location *	CR
Category	Earthen Levee			GPS Latitude/Longitude	
				Start	End
Item	Crown Surface / Depressions / Rutting			38.255197 °	38.254973 °
				-121.737932 °	-121.737577 °
DWR ID	DWR_RD0536_01_f_2014_56				
Comment Code					
C2 : Repair depressions or ruts in the crown or slope.					
Inspector Comment					
District need to monitor the levee crown roadway at this location. There are some issues here.

RD 536 Unit 1 looking downstream from 2.69 to levee mile 2.71.

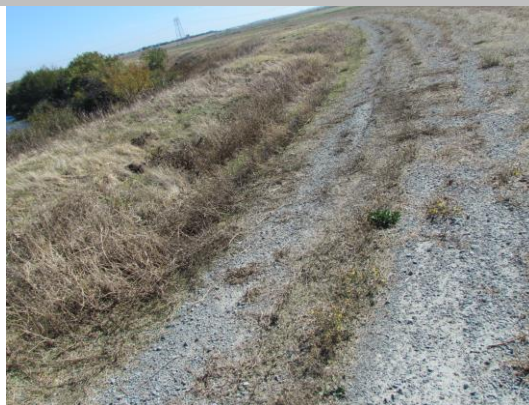
Photo 2 of 4 : SP_2017_RD0536_208_56_20170404_00010.jpg

RD 536 Unit 1 levee mile 2.69 another angle of the subsidence.

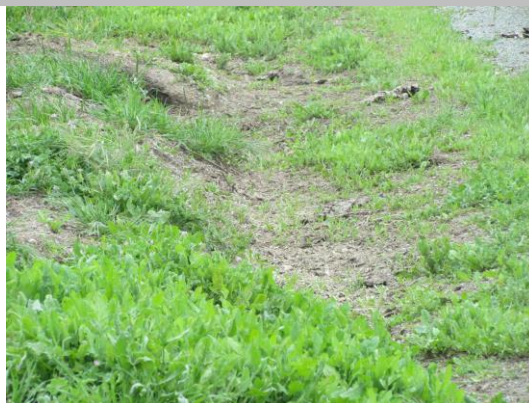
Photo 3 of 4 : SP_2017_RD0536_208_56_20170519_00048.jpg

RD 536 Unit 1 levee mile 2.69-2.71 there is a settling issue going on here at this levee site.

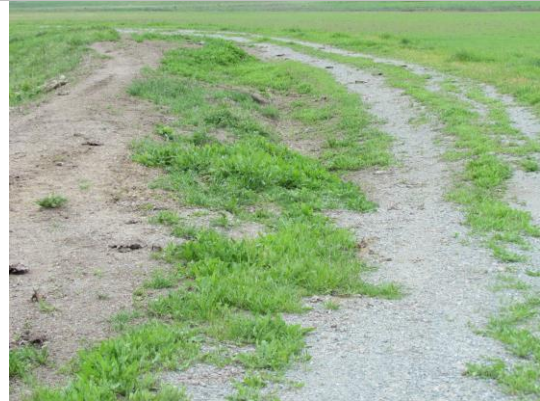
Photo 4 of 4 : SP_2017_RD0536_208_56_20170519_00047.jpg

RD 536 Unit 1 looking downstream from levee mile 2.69 to 2.71.

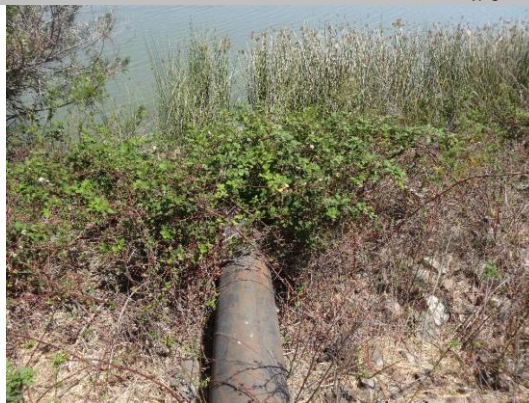
Photo 1 of 3 : UCIP_SP_2017_49314_34789.jpg

FS_ID:49314
DS_ID:24023
EP_NO: N/A
Repair Type: Non-Urgent
Crossing Status: Found
UCIP Comments: 06/01/2016 Could not see flapgate in water. Pipes still in use. No cover over pressure relief valve on WS slope. 08/13/2013:- Field discovered pipe.- Needs more information from the LMA/ DWR Inspector. - Dense vegetation on WS.- Pump feeds both pipes.
FIELD_STRUCT_DESC: 1 of 2: 18-inch steel drainage pipe through the levee, approximately 4 feet below the crown. Pump (called the "Buddha pump") in pump house on the landside (LS) at the drainage ditch. Pressure breaker on the waterside (WS) slope. Pump and pipes are used by the district (per district president David Hearn) but could not identify permit information. Landowner is Dan Hearn per Solano County Assessor's Office (Parcel No. 0042-180-220).
FS Date: 6/1/2016

WS view: exposed 18" steel pipe on levee slope.

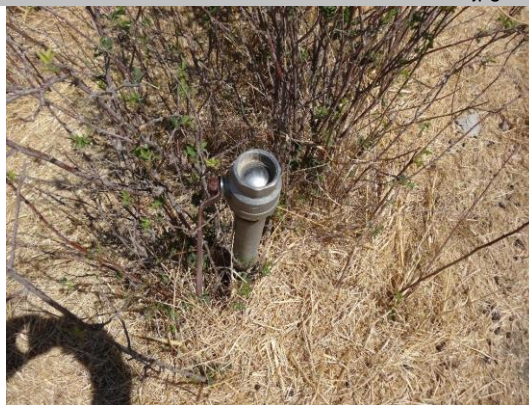
Photo 2 of 3 : UCIP_SP_2017_49314_34788.jpg

WS view: pressure breaker/valve on levee slope.

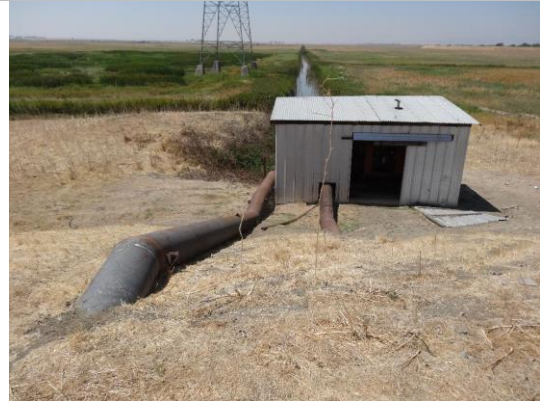
Photo 3 of 3 : UCIP_SP_2017_49314_34787.jpg

WS view: exposed 18" steel pipe (left) and 16" steel pipe (right) on levee slope. Pump house on bank of drainage ditch.

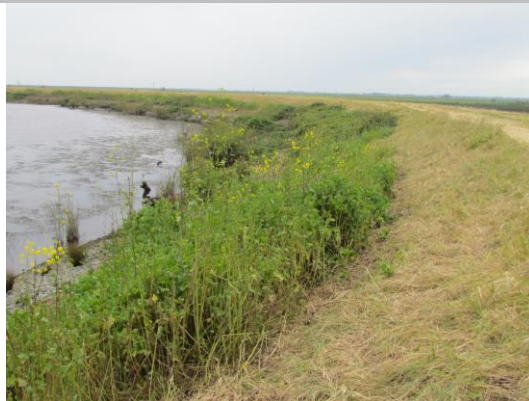
Photo 1 of 1 : SP_2017_RD0536_208_29_20170519_00050.jpg

RD 536 Unit 1 looking downstream from levee mile 3.71-4.37 waterside slope.

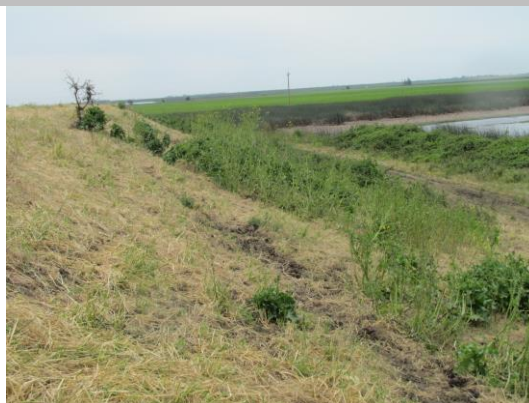
Photo 1 of 1 : SP_2017_RD0536_208_30_20170519_00049.jpg

LM Start	3.78	Rating **	U	Issue No.	30
LM End	4.70	Issue Type +	Ma	Location *	LS
Category	Earthen Levee			GPS Latitude/Longitude	
				Start	End
Item	Vegetation			38.251197 °	38.247307 °
				-121.725697 °	-121.711675 °
DWR ID	DWR_RD0536_01_s_2017_30				
Comment Code					
V2 : Remove the wild growth other than native grasses from the levee slopes.					
Inspector Comment					
Remove the wild vegetation on the landside slope.

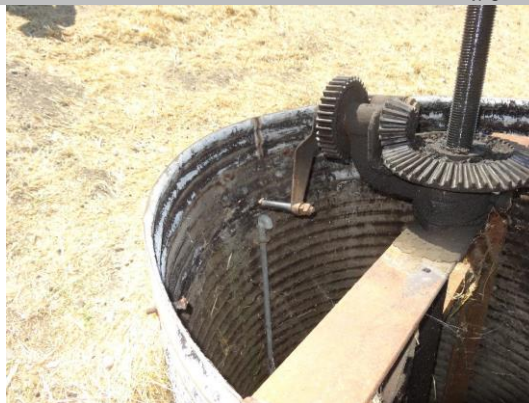
Photo 3 of 3 : UCIP_SP_2017_20503_34566.jpg

WS view: closer view of slide gate in CMP riser on levee slope. Air vent attached to the wall of CMP (left).

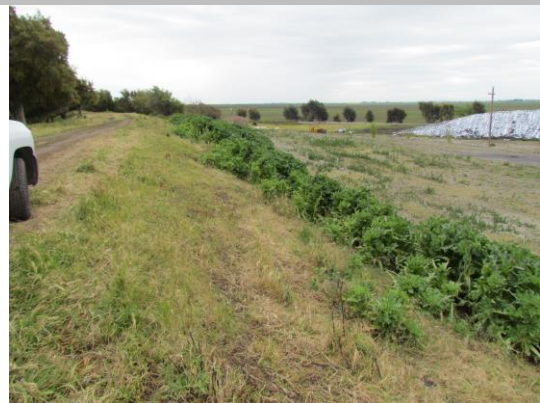
Photo 1 of 1 : SP_2017_RD0536_208_34_20170519_00051.jpg

RD 536 Unit 1 levee mile 4.81-4.96 landside levee slope.

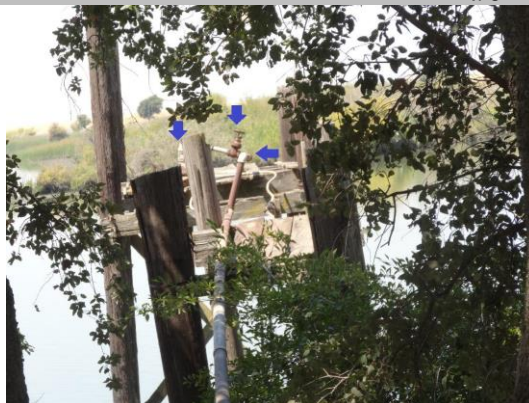
Photo 1 of 3 : UCIP_SP_2017_49318_34605.jpg

Comment Code					
Inspector Comment					
FS_ID:49318 DS_ID:22720 EP_NO: 10116 Repair Type: Non-Urgent Crossing Status: Found UCIP Comments: 06/01/2016 Pipe is an abandoned crossing per conversation with district president David Hearn.Pipe seems to be abandoned.Catwalk and pumphouse on riverside not found. It is not clear whether the pipe pass through the levee or not. Needs more info from LMA/DWR Inspector. FIELD_STRUCT_DESC: 3-inch B.I. galvanized pipe through levee 4.0 feet below crown. Concrete cradle and tank on waterward slope (ABO No.10116, 1975). Catwalk and pumphouse on riverside. Originally included in the 1953 O&M manual, Sac 106, May 1953. FS Date: 8/13/2013

WS view: pump, pipe, gate valve, and wooden piling structure in the stream.

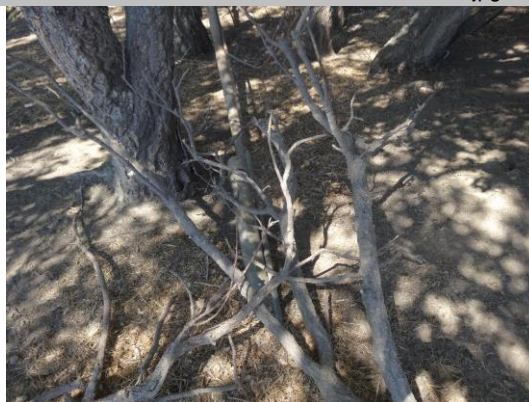
Photo 2 of 3 : UCIP_SP_2017_49318_34604.jpg

WS view: exposed pipes on levee shoulder.

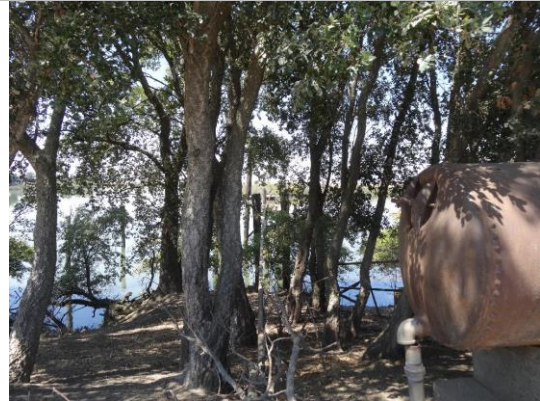
Photo 3 of 3 : UCIP_SP_2017_49318_34603.jpg

WS view: concrete cradle and abandoned steel tank on levee shoulder.

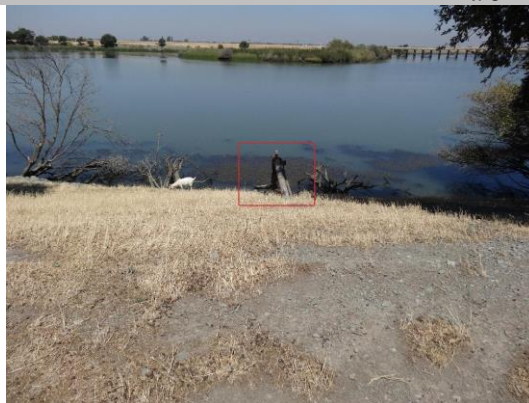
Photo 1 of 2 : UCIP_SP_2017_49319_35124.jpg

FS_ID:49319
DS_ID:24664
EP_NO: N/A
Repair Type: Non-Urgent
Crossing Status: Found
UCIP Comments: 06/01/2016 According to district president David Hearn, landowner is Silva and crossing is abandoned.08/13/2013:Field discovered pipe crossing.Needs more information from LMA/DWR Inspector. Also needs more detailed inspection.
FIELD_STRUCT_DESC: Approximately 6-inch steel pipe and an electric conduit through levee. A slant pump in steel support on channel bank. Gate valve on the pipe. No pipes and appurtenances on landside. Field discovered pipe crossing.
FS Date: 8/13/2013

WS view: pipe and pump on channel bank.

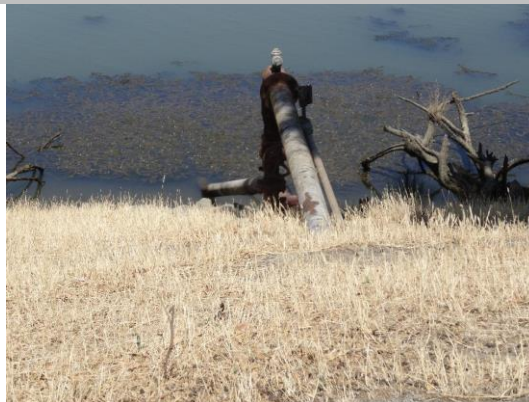
Photo 2 of 2 : UCIP_SP_2017_49319_35123.jpg

WS view: closer view of pipe and pump on channel bank.

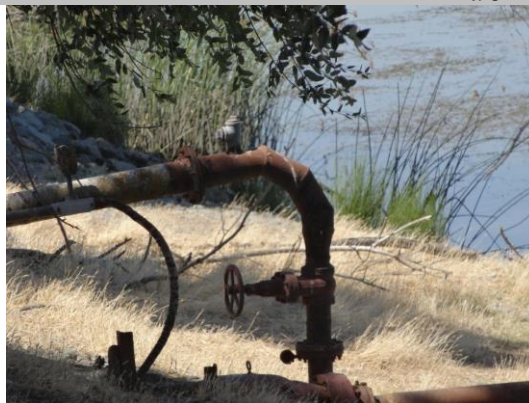
Photo 1 of 2 : UCIP_SP_2017_20543_34623.jpg

WS view: abandoned pipe, pump, conduit, and gate valve on levee slope.

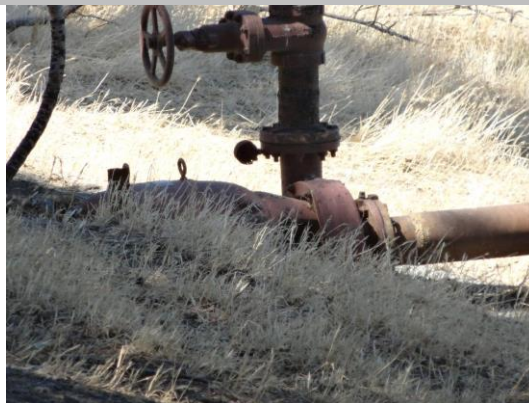
Photo 2 of 2 : UCIP_SP_2017_20543_34622.jpg

WS view: closer view of abandoned pipe, pump, and gate valve on levee slope.

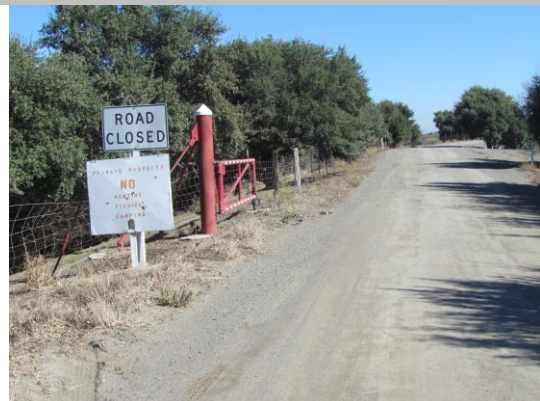
Photo 1 of 2 : SP_2017_RD0536_208_11_20170404_00002.jpg

RD 536 Unit 1 levee mile 5.34 waterside shoulder. No change. 4-17.

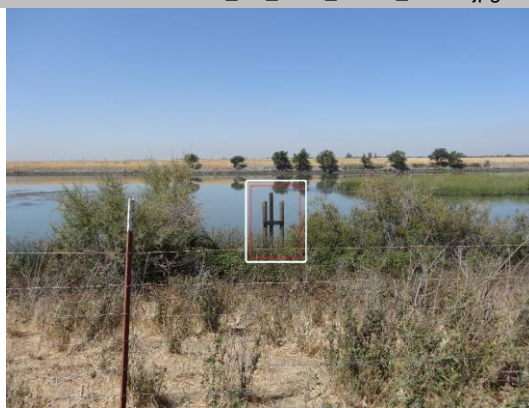
Photo 1 of 3 : UCIP_SP_2017_20563_34646.jpg

WS view: wooden & steel piles on the slough. Probably the supports are for pipe and flap gate. Not accessible due to fence.

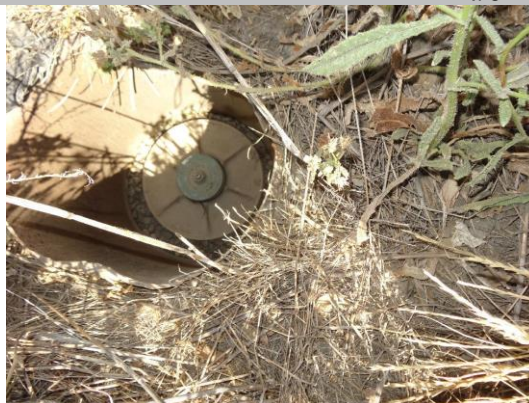
Photo 2 of 3 : UCIP_SP_2017_20563_34645.jpg

WS view: uncovered siphon breaker on levee shoulder. It needs protection.

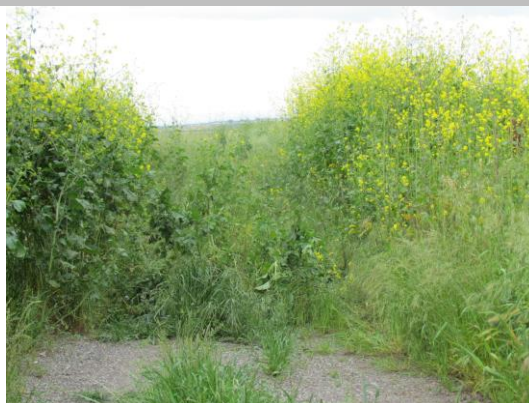
Photo 1 of 1 : SP_2017_RD0536_209_10_20170519_00018.jpg

LM Start	0.10	Rating **	U	Issue No.	10
LM End	5.01	Issue Type +	Ma	Location *	CR
Category	Earthen Levee			GPS Latitude/Longitude	
				Start	End
Item	Vegetation			38.244083 °	38.198750 °
				-121.696923 °	-121.710381 °
DWR ID	DWR_RD0536_02_s_2017_10				
Comment Code					
V9 : Keep the crown roadway free of vegetation.					
Inspector Comment					
Keep the crown roadway free of vegetation.

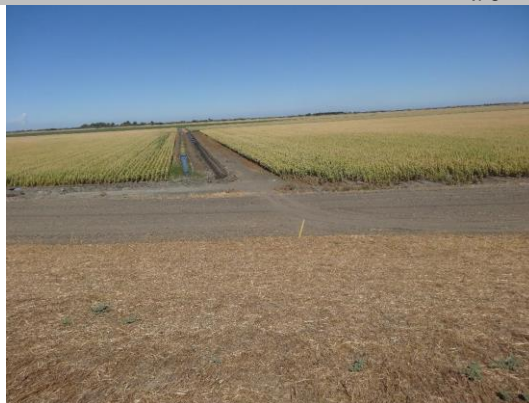
Photo 1 of 3 : UCIP_SP_2017_20664_34746.jpg

WS view: overview of levee slope and gasline indicator. The indicator is different than standard indicators.

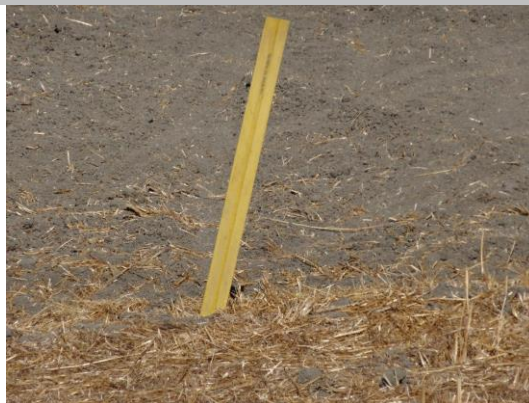
Photo 2 of 3 : UCIP_SP_2017_20664_34745.jpg

WS view: closer look at gasline indicator. The indicator is different than standard indicators.

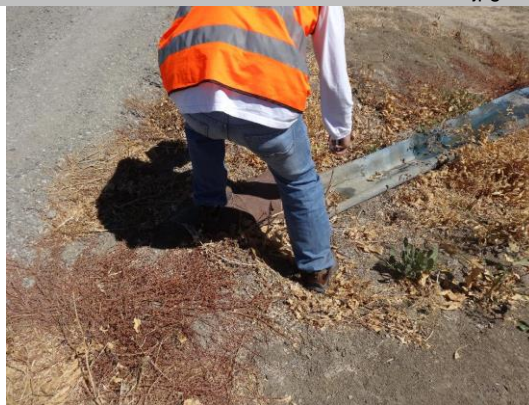
Photo 3 of 3 : UCIP_SP_2017_46813_34766.jpg

WS view: steel pipe on levee shoulder at 2-inch below the crown.
